FHWA- INVESTIGATION OF THE EFFECTIVENESS OF EXISTING
RD- GE DESIGN METHODOLOGY IN PROVIDING ADEQUATE
73-13 STRUCTURAL RESISTANCE TO SEISMIC DISTURBANCES.

Phase I: Literature Survey

T. Iwasaki, J. Penzien, and R. Clough

November 1972
Final Report

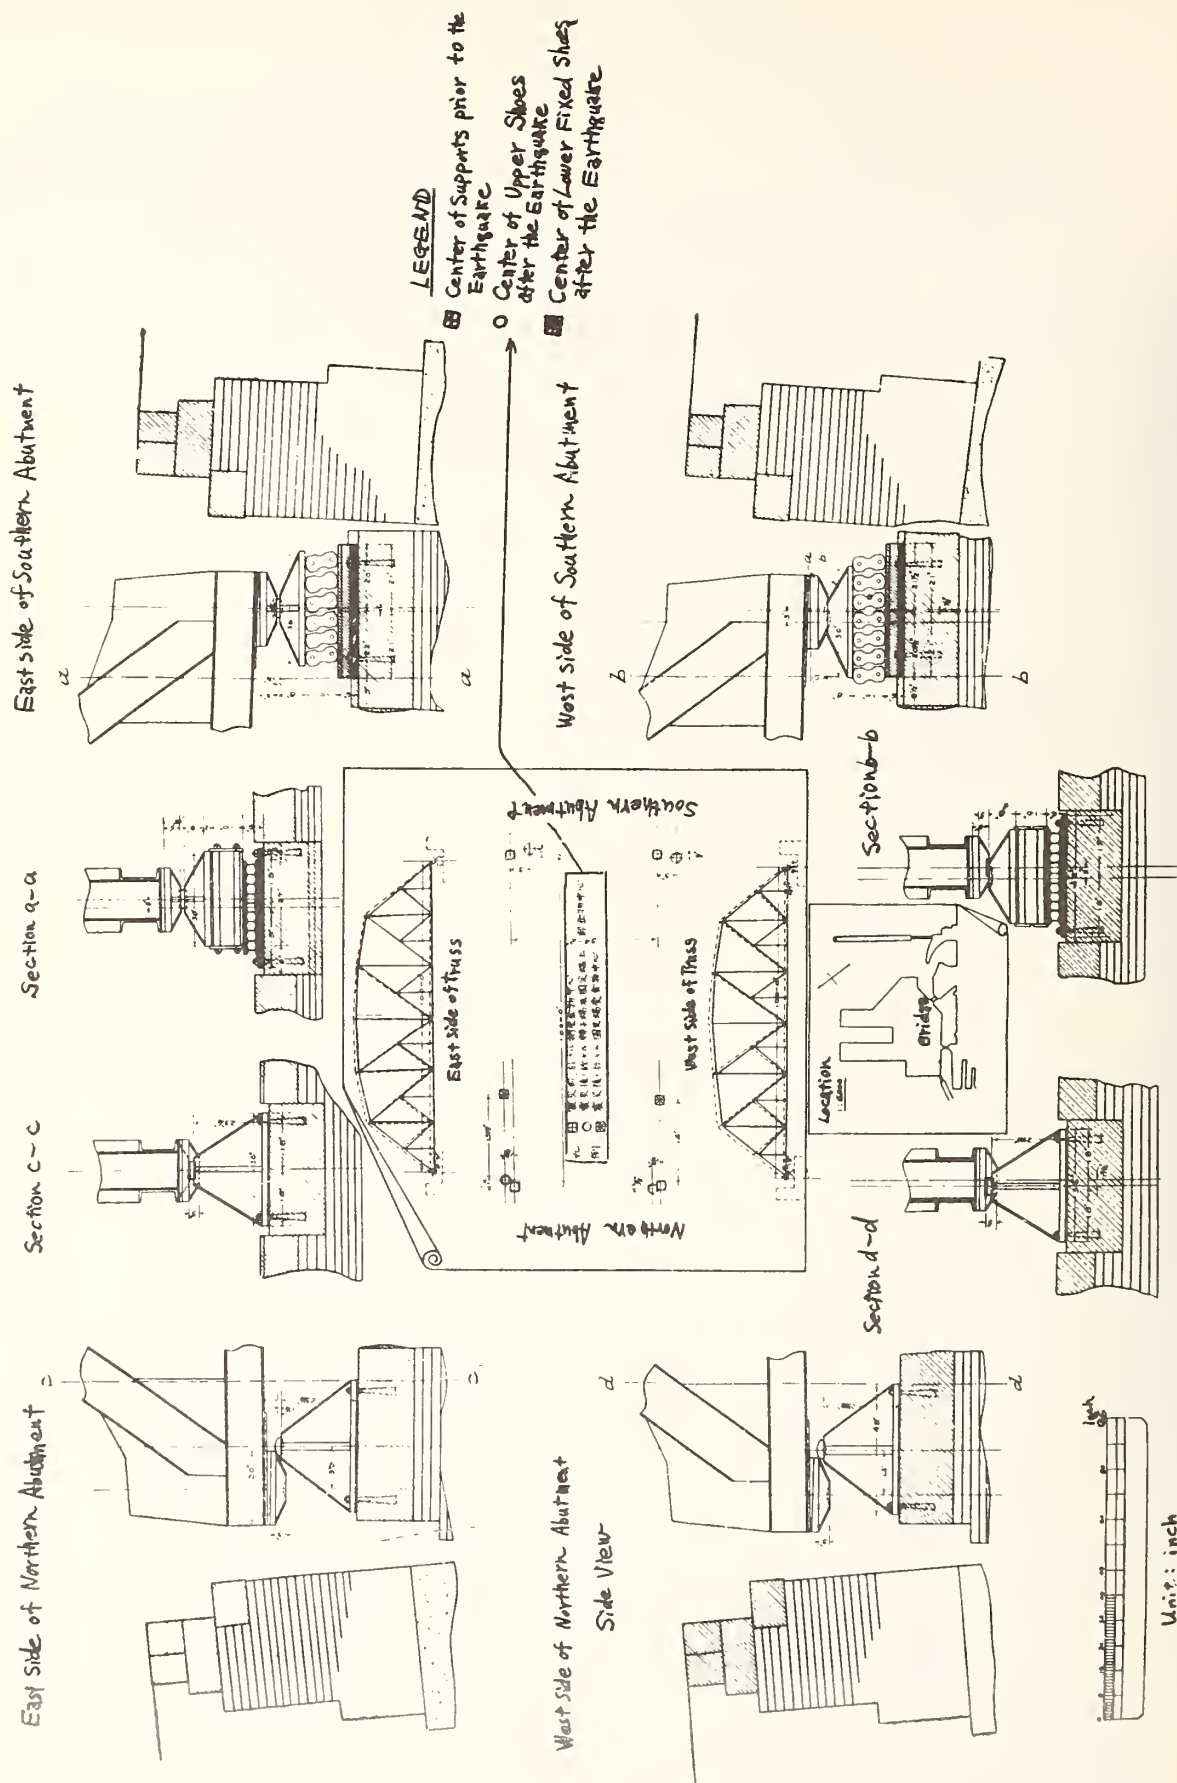
Fig. 2.3 Damage to the Tsuruno-bashi bridge

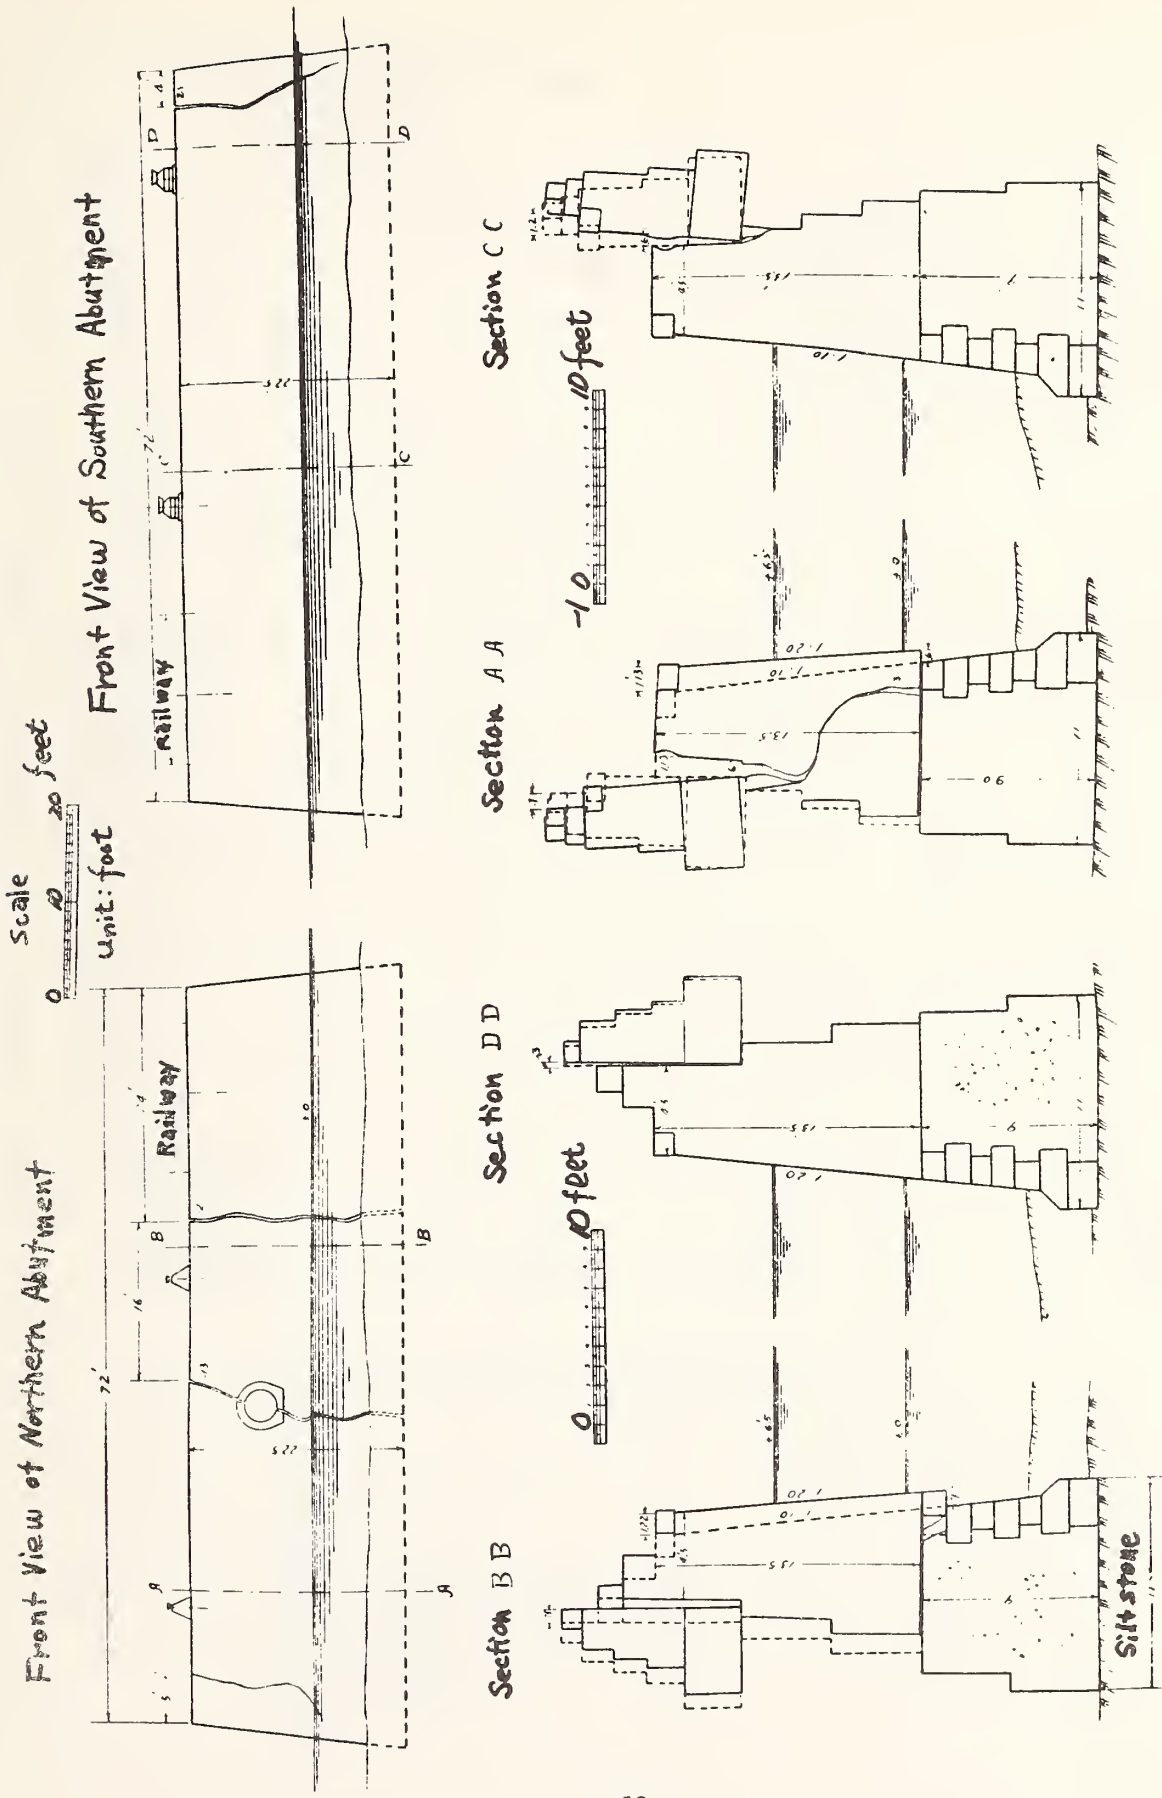
Fig. 2.4 Damage to the Shinminato bridge

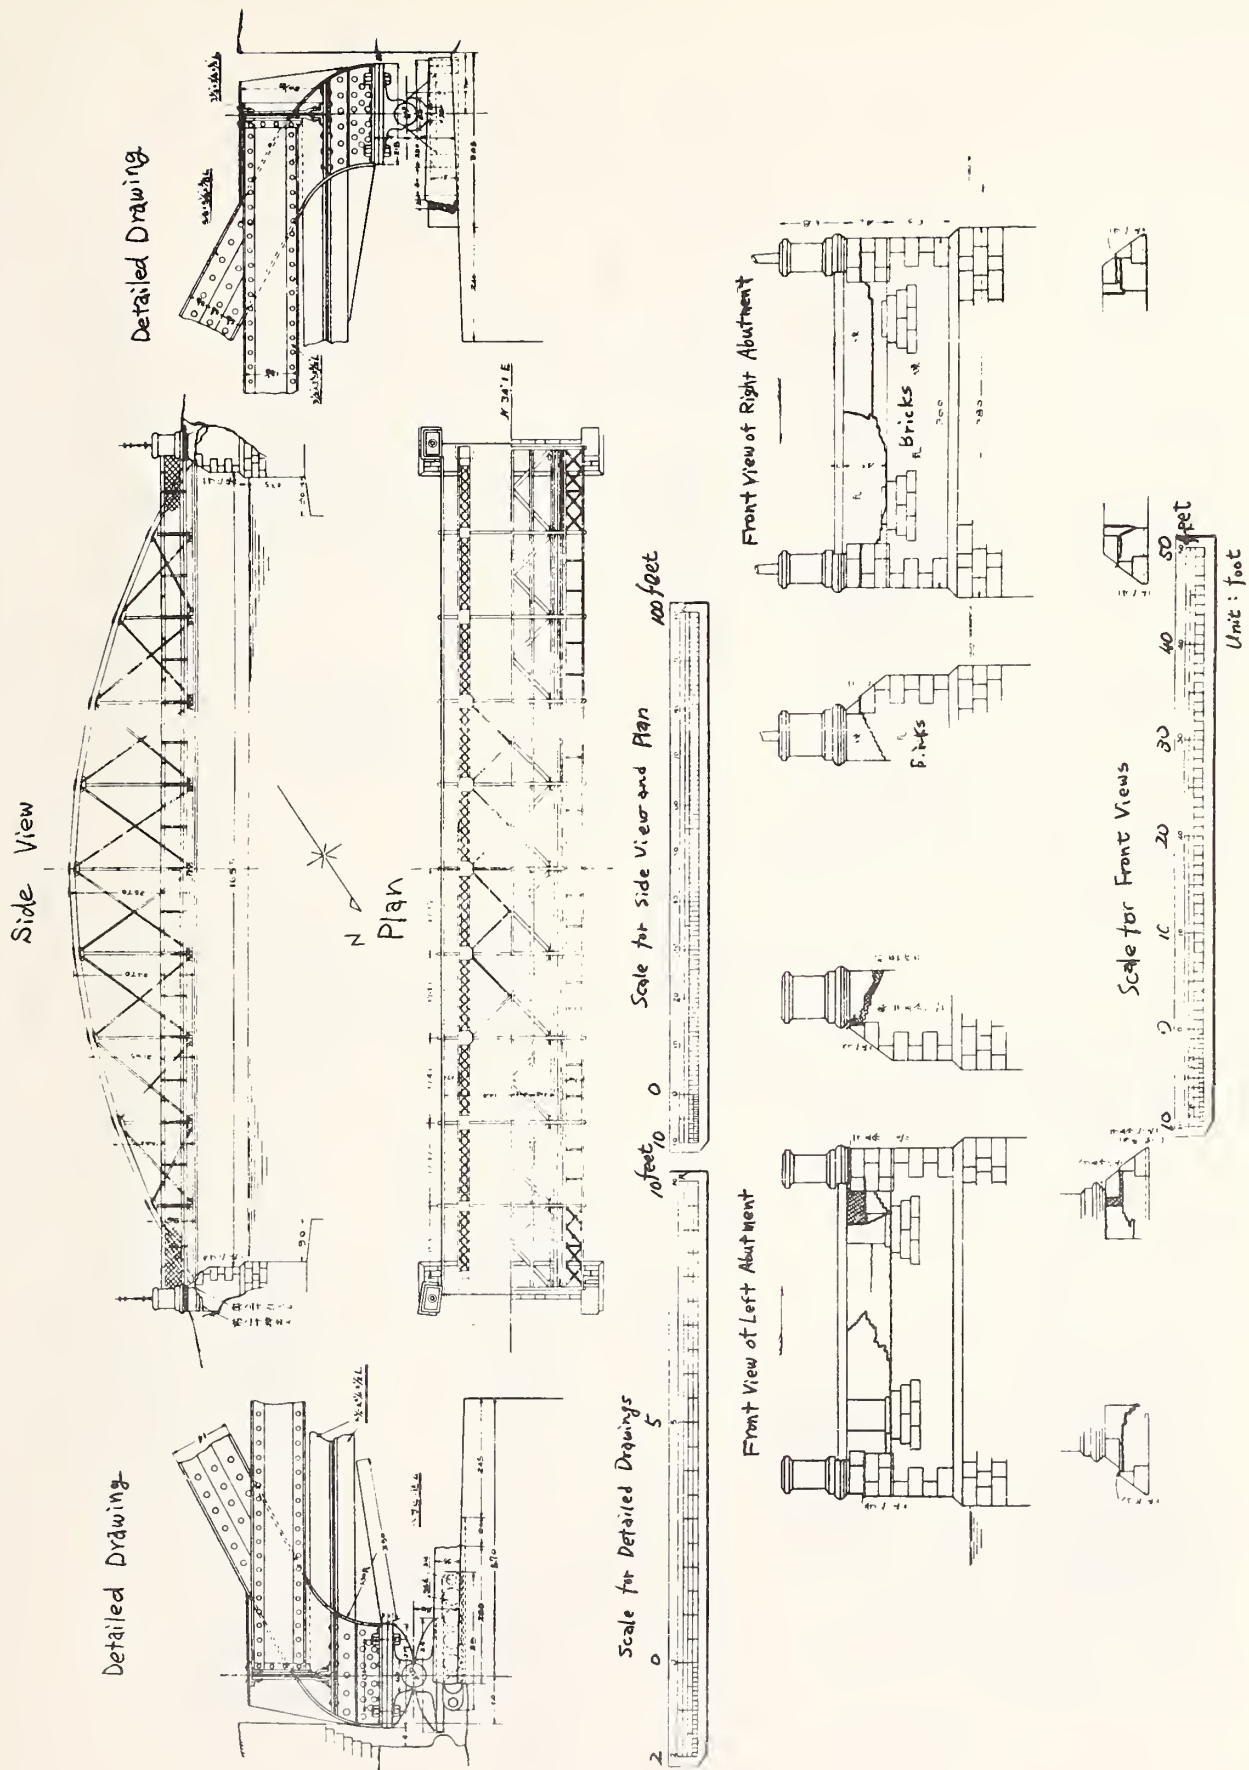
Fig. 2.5 Damage to the abutments of the Shinminato bridge

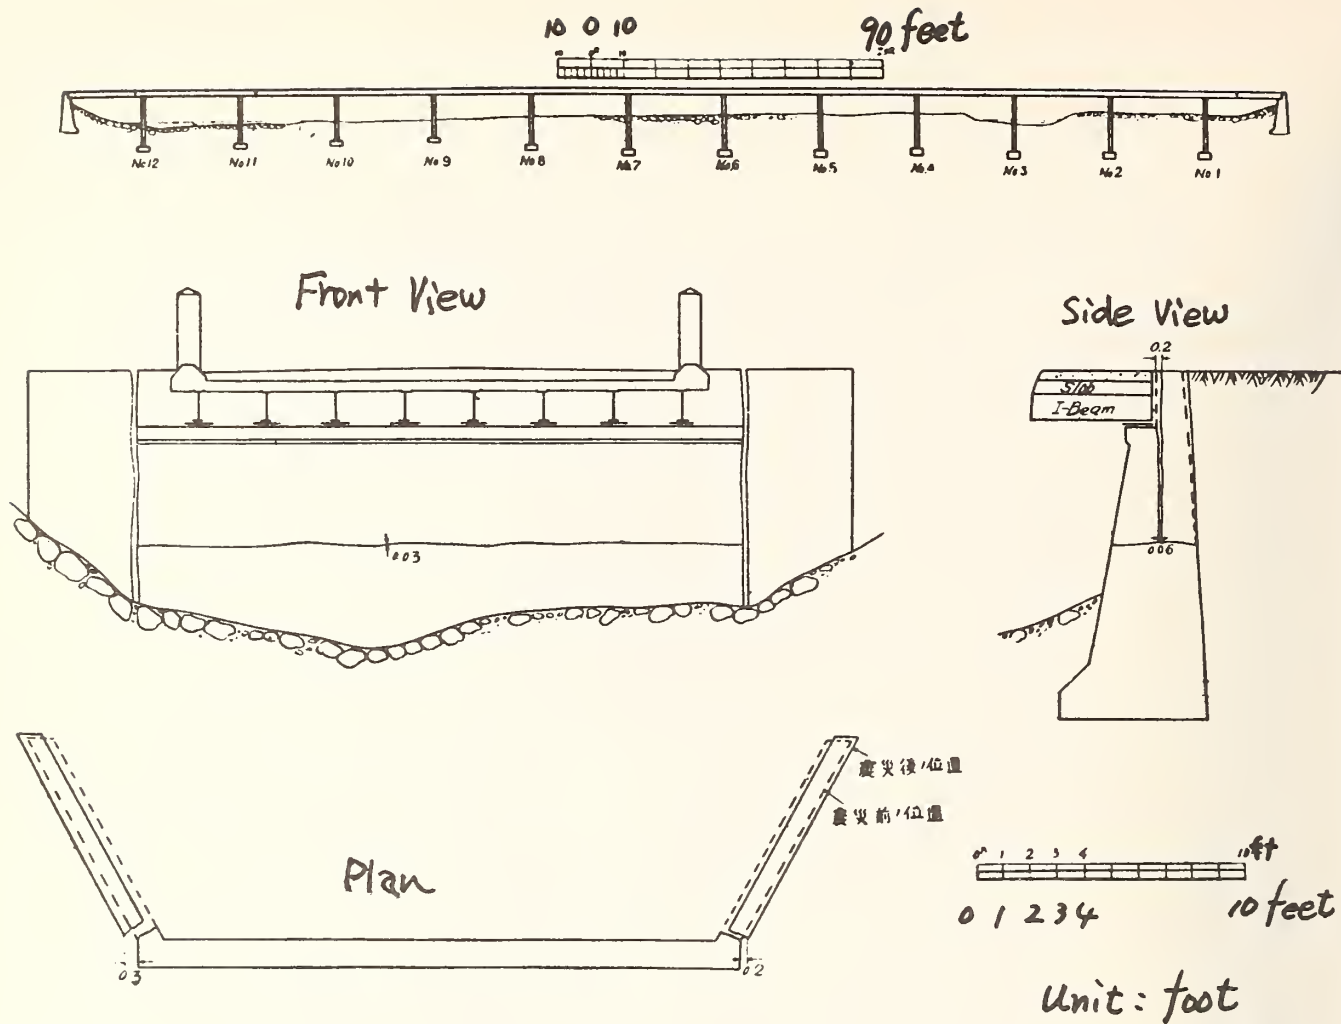
Fig. 2.11 Damage to the Hayakawa bridge

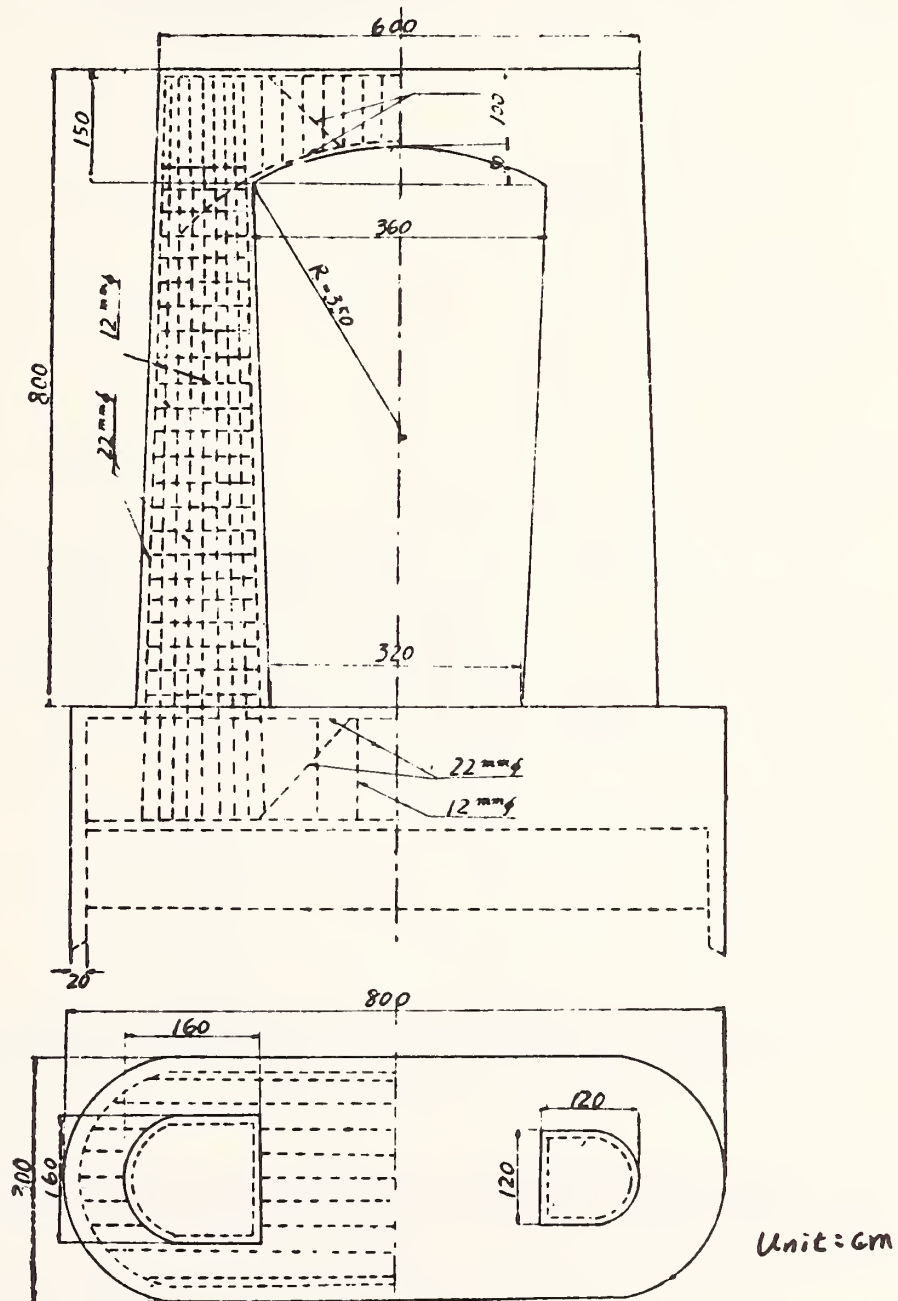
Fig. 2.15 Damage to the Nakazuno bridge

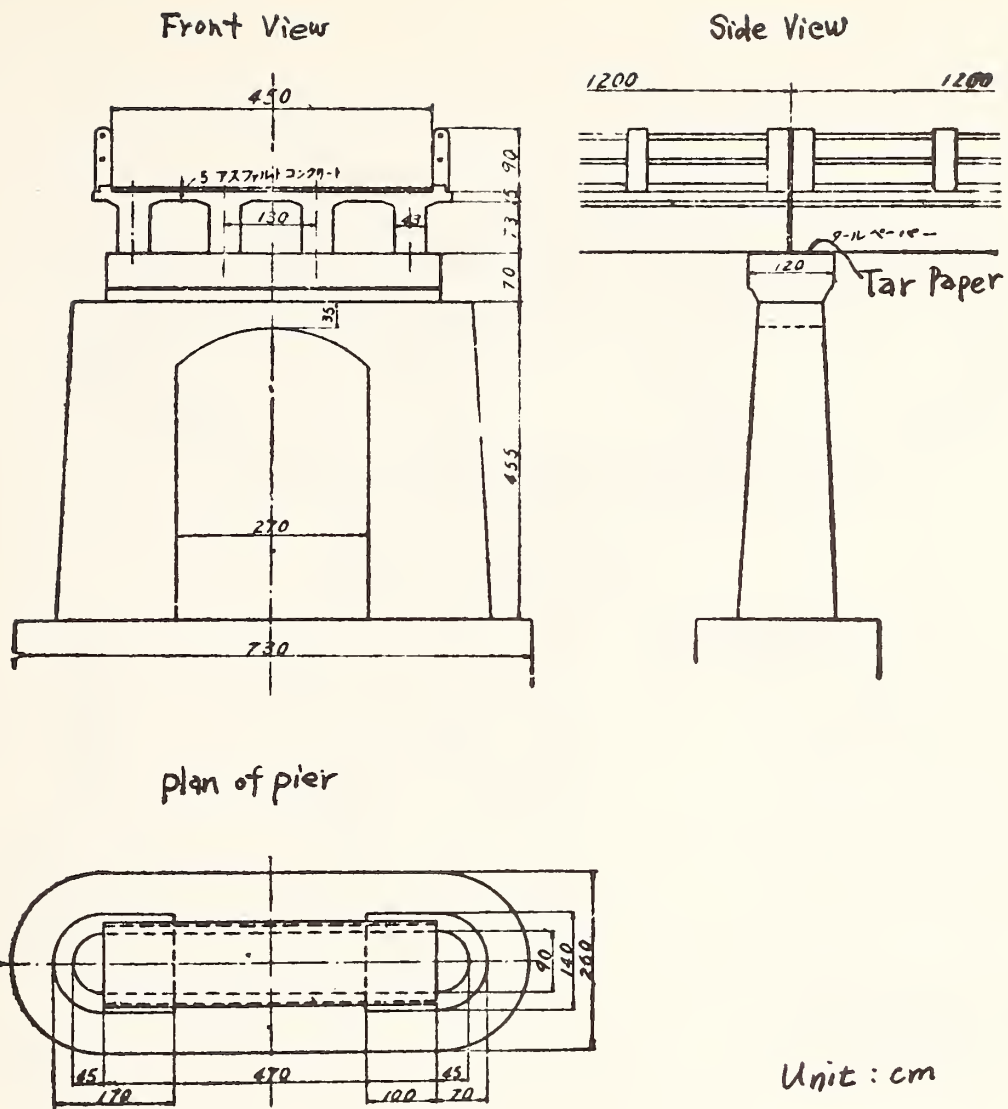
Fig. 2.18 Damage to the Nagaya bridge

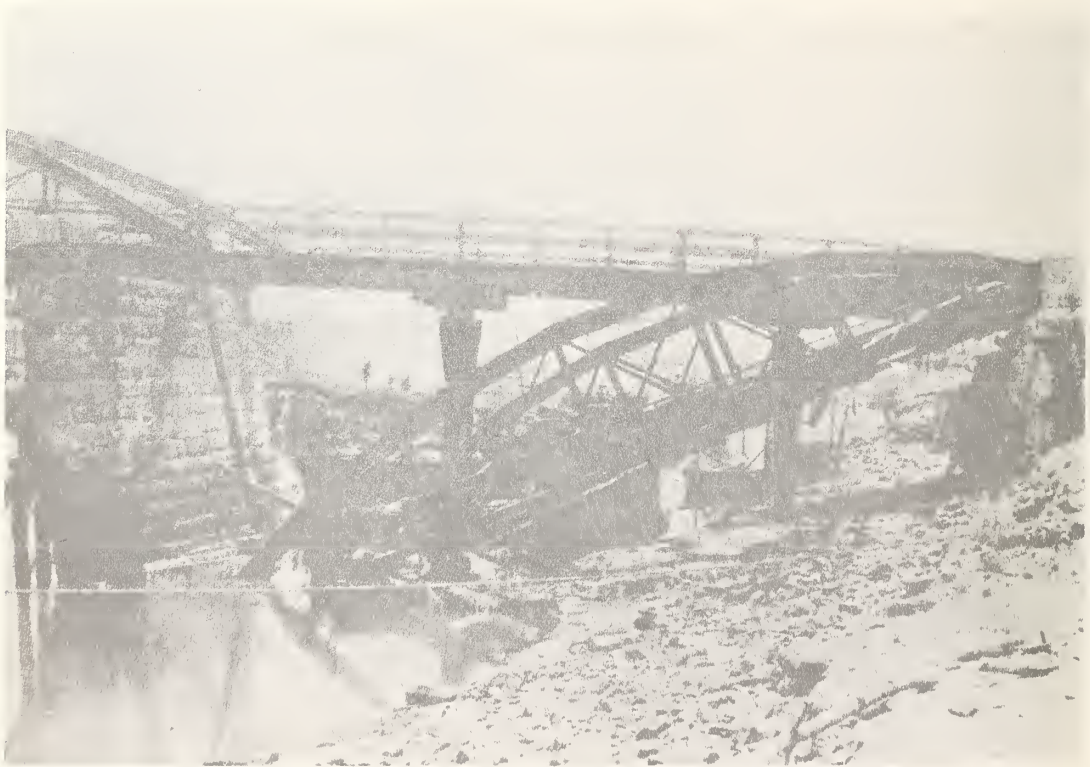
Photo.2.7 Damage to the Toyokuni bridge

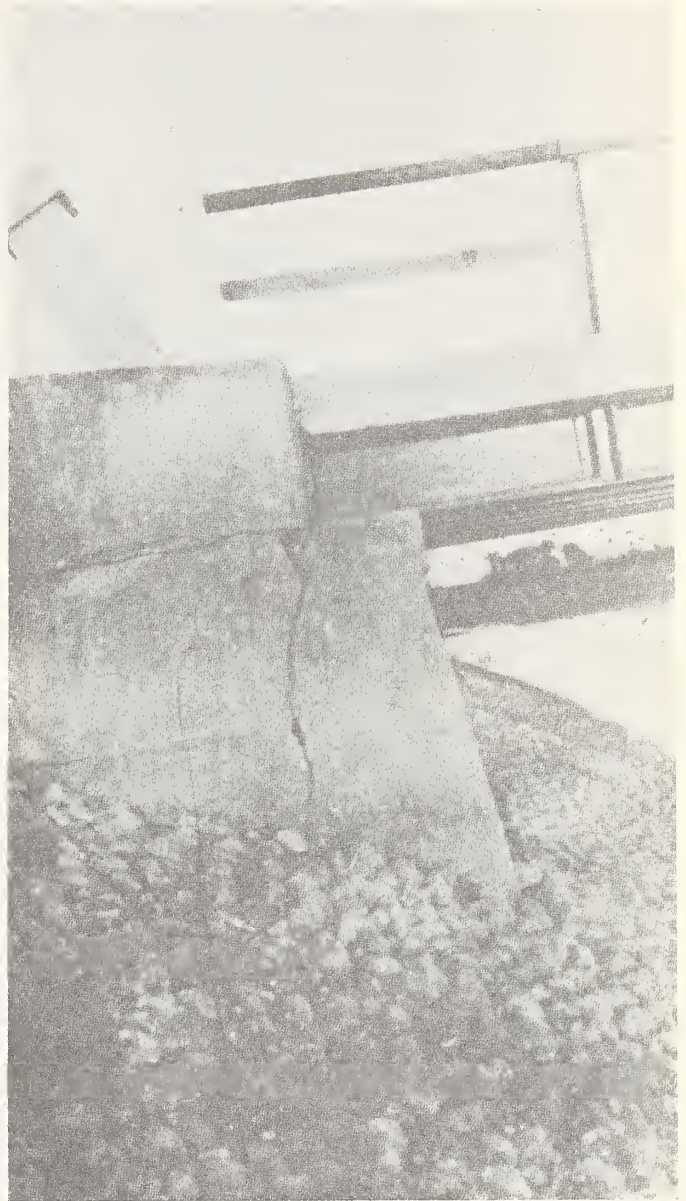
Photo.2.17 Damage to the fifth pier of the Takahata bridge.

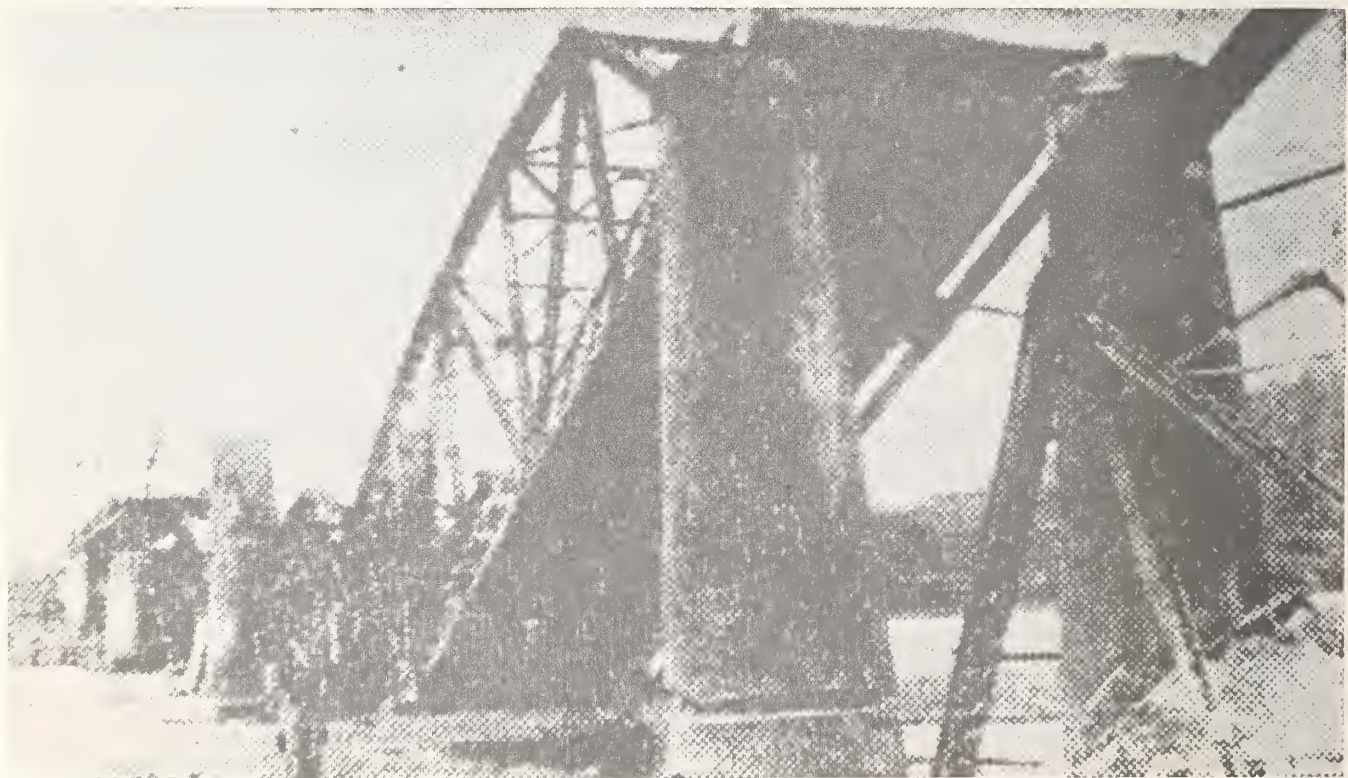
Photo.2.19 Damage to the support shoes of the Kumano bridge

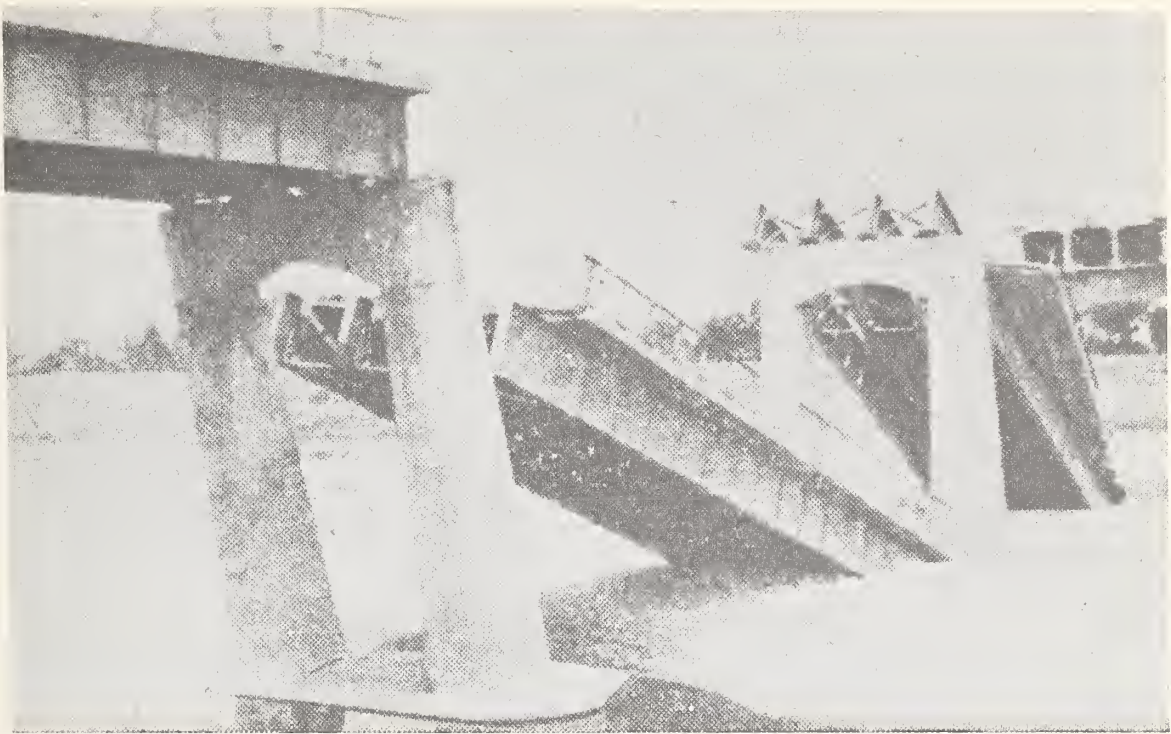
Photo.2.20 Damage to the Shimantogawa bridge

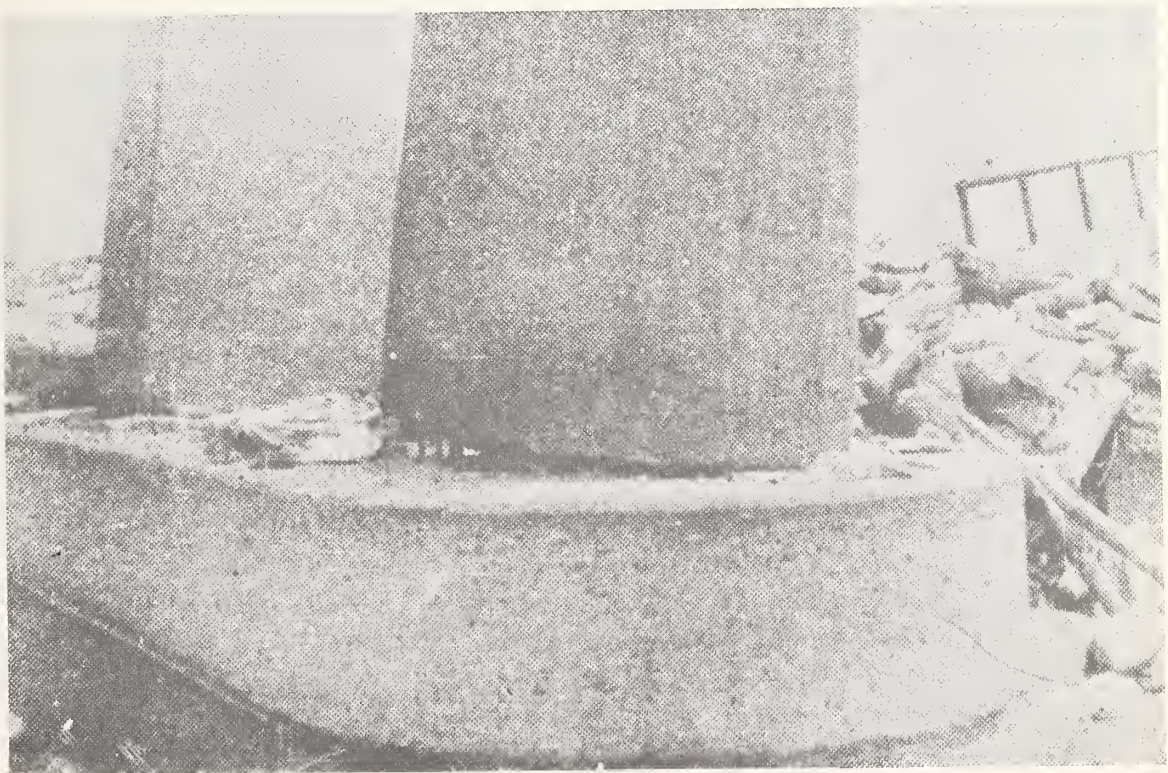
Photo.2.21 Damage to the Nakazuno bridge

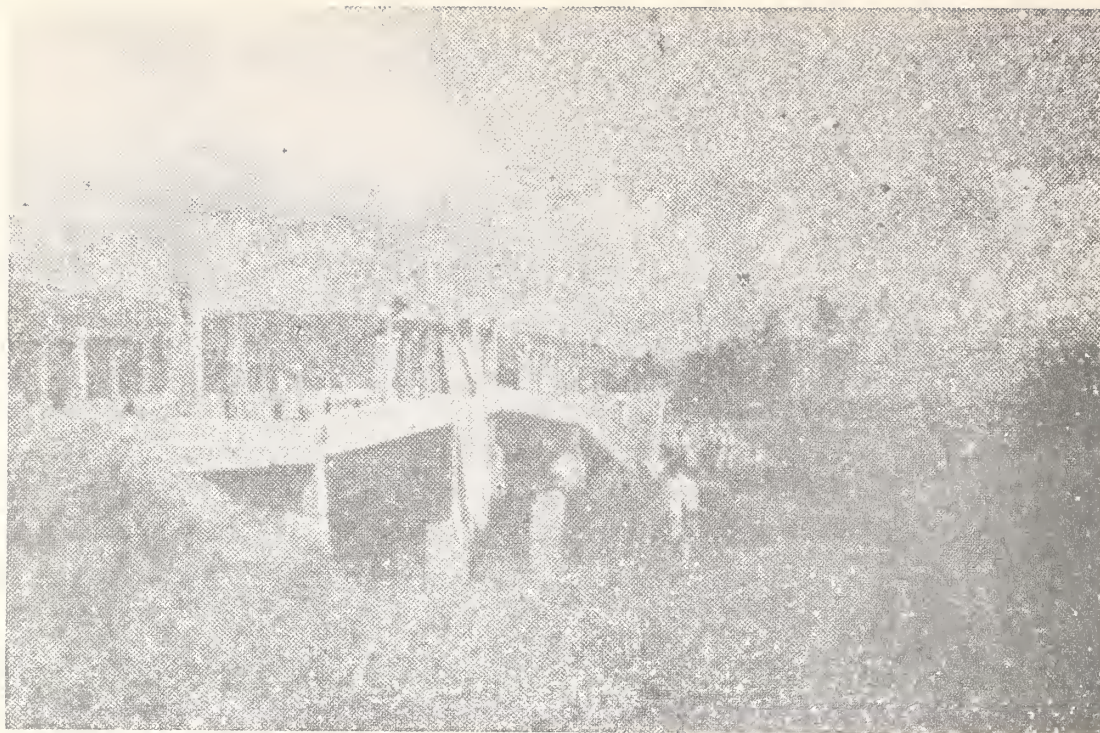
Photo.2.26 Damage to the girders of the
Nakazuno bridge

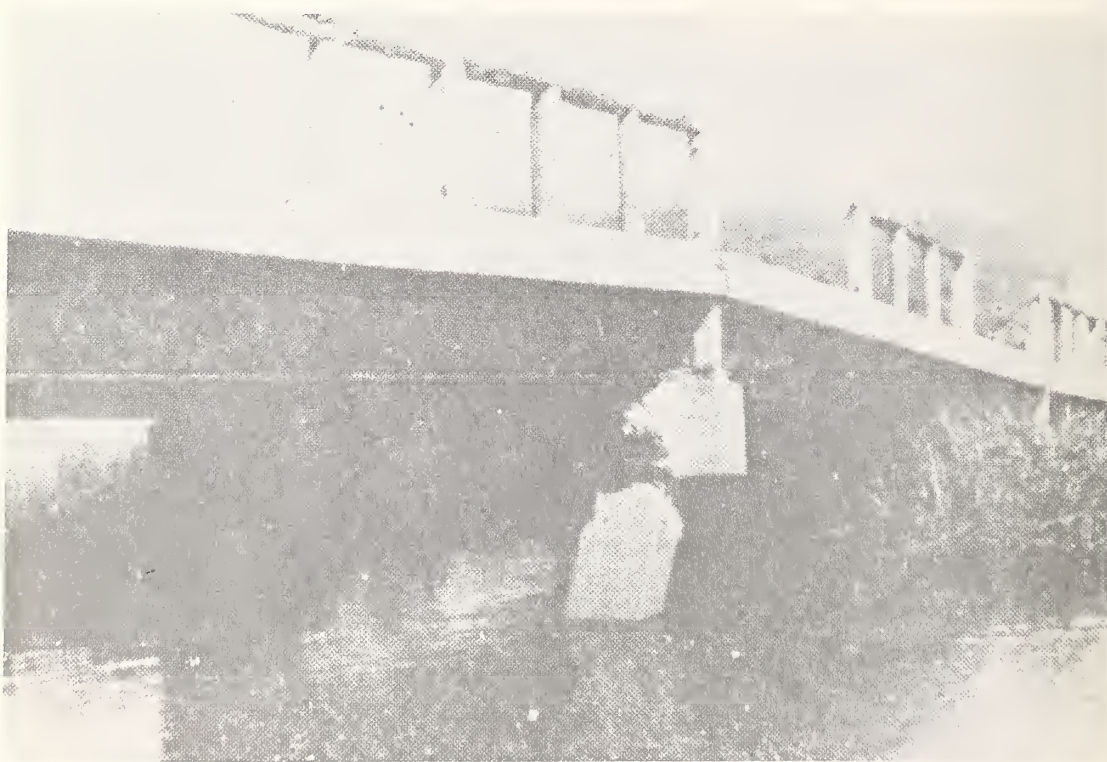
Photo.2.27 Damage to the Nagaya bridge

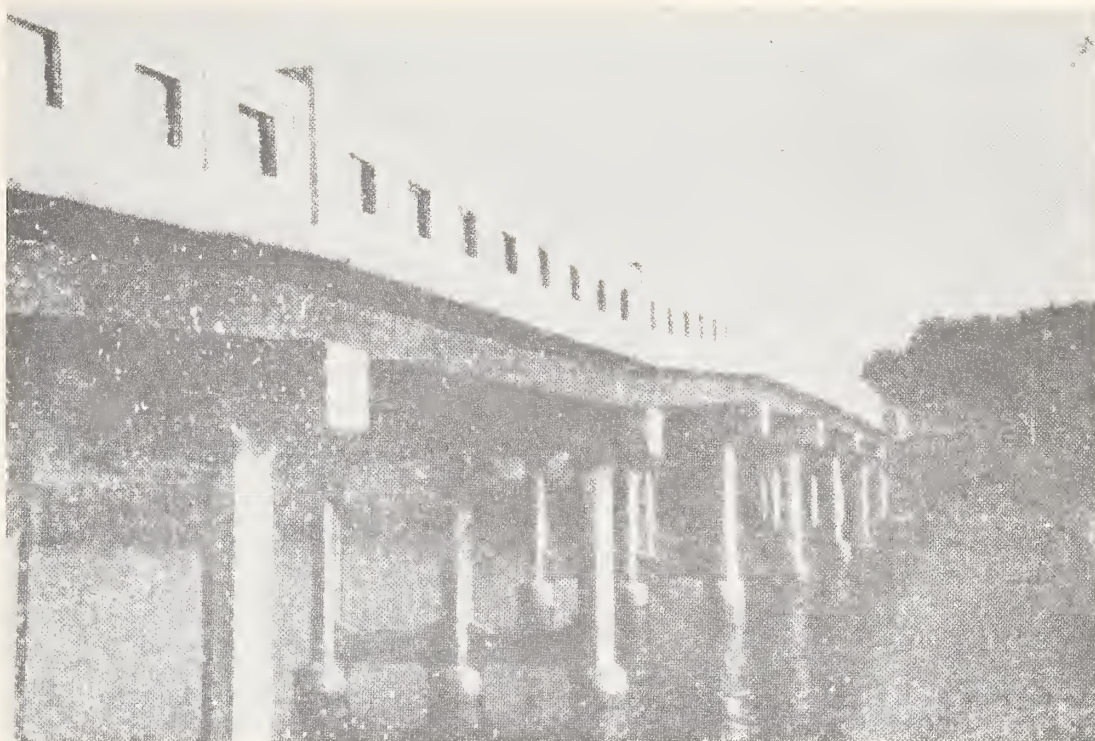
Photo.2.28 Damage to the piers of the Nagaya bridge

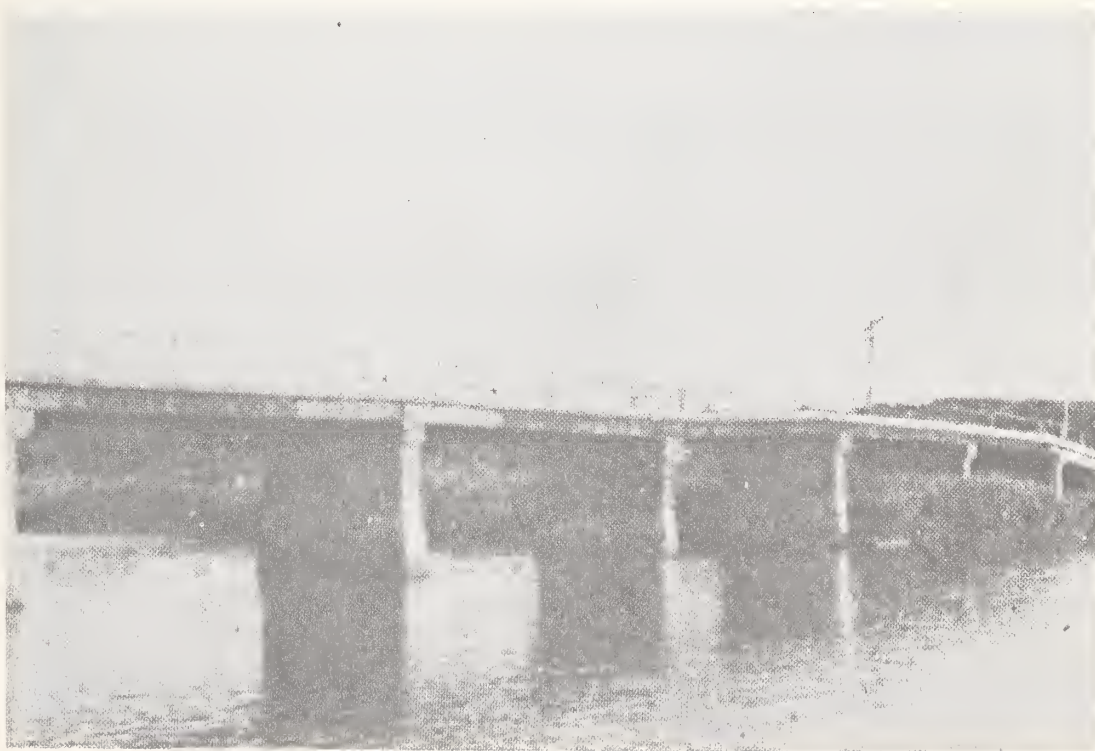
Photo.2.29 Damage to the Shioya bridge

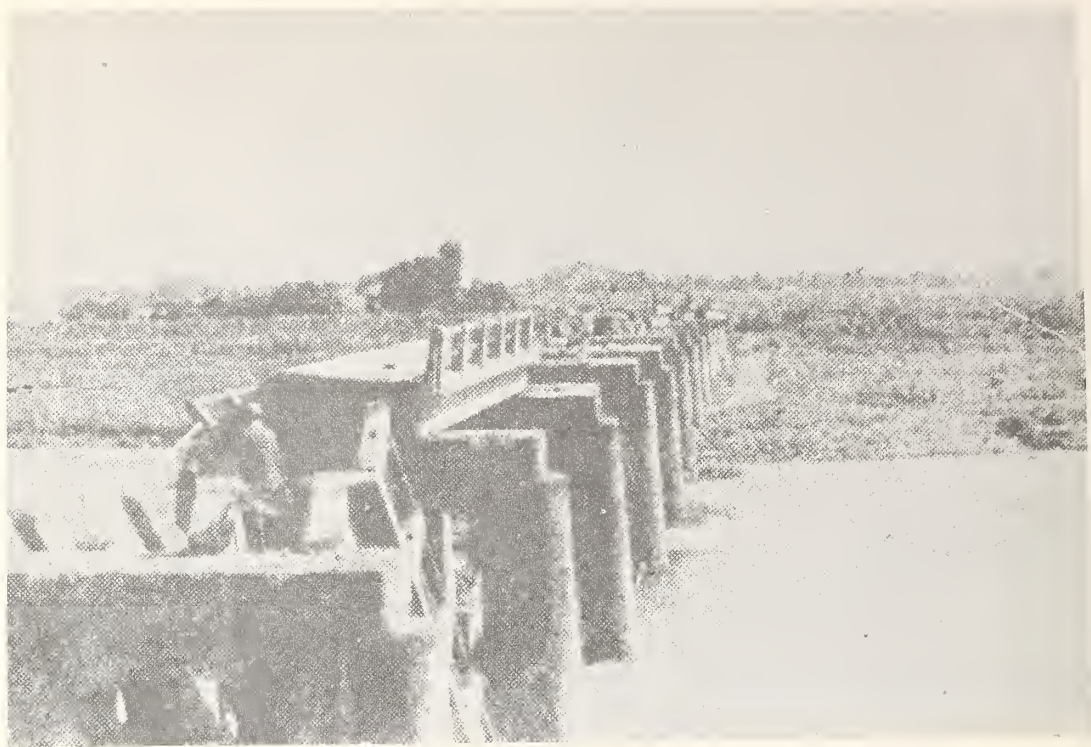
Photo.2.30 Damage to the Segoshi bridge

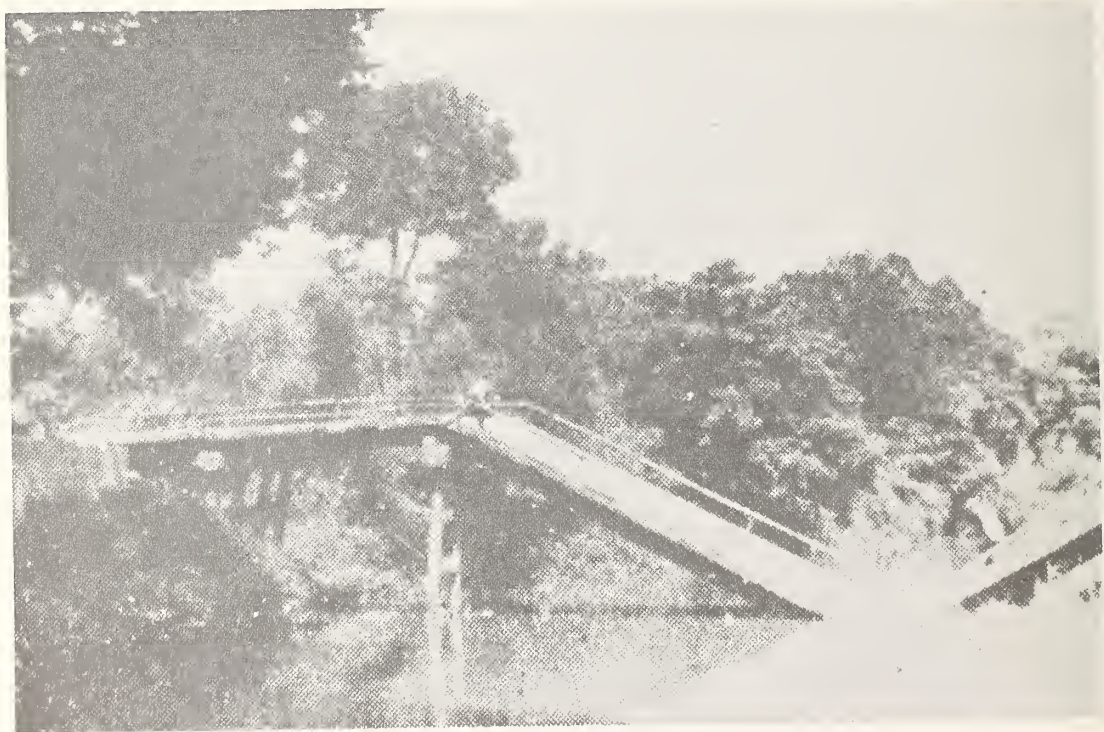
Photo.2.31 Damage to the Itagaki Bridge

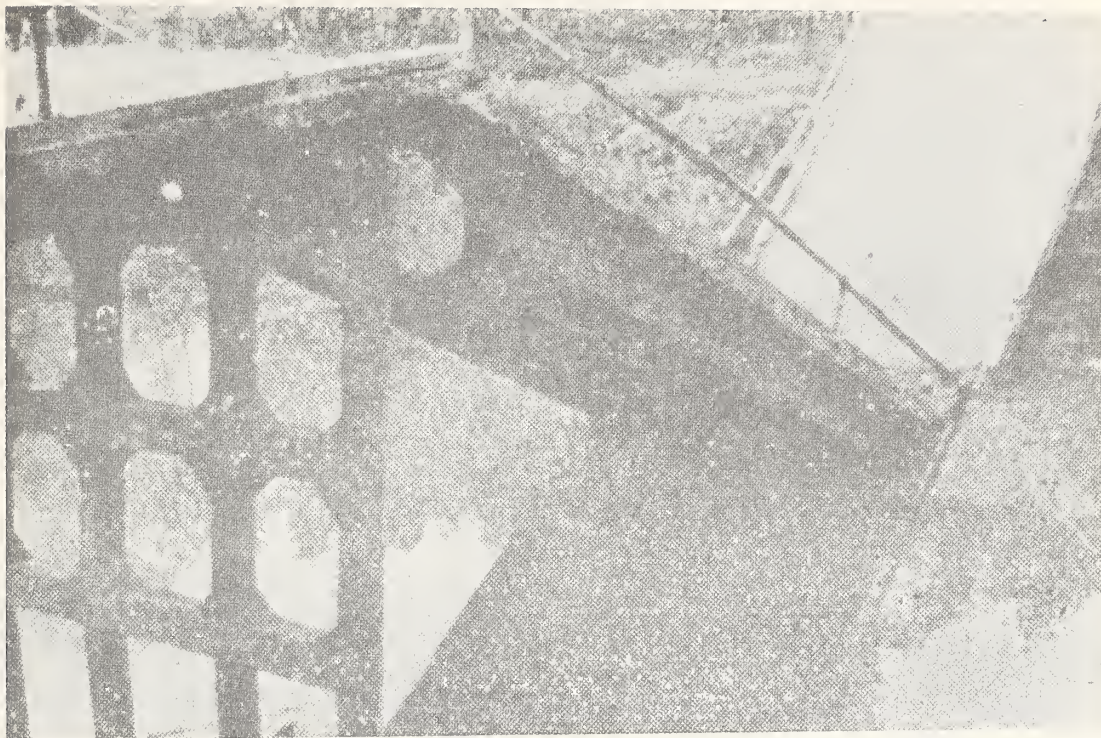
Photo.2.32 Damage to the Benten bridge

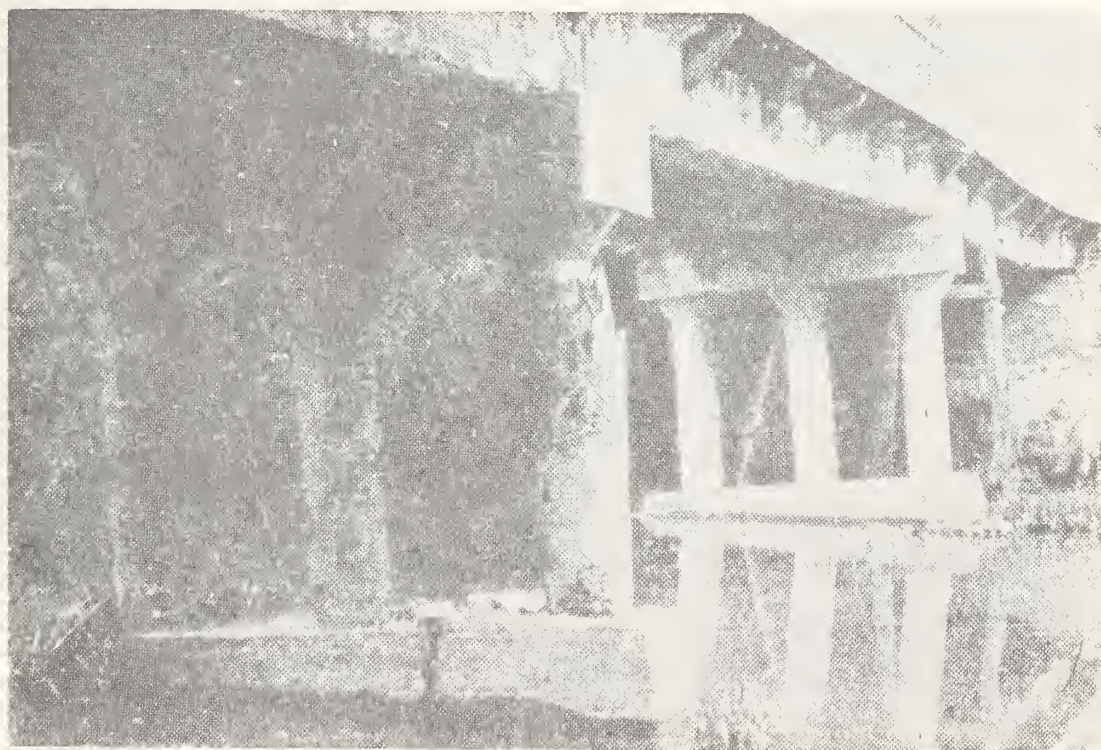
Photo.2.33 Damage to the Benten bridge

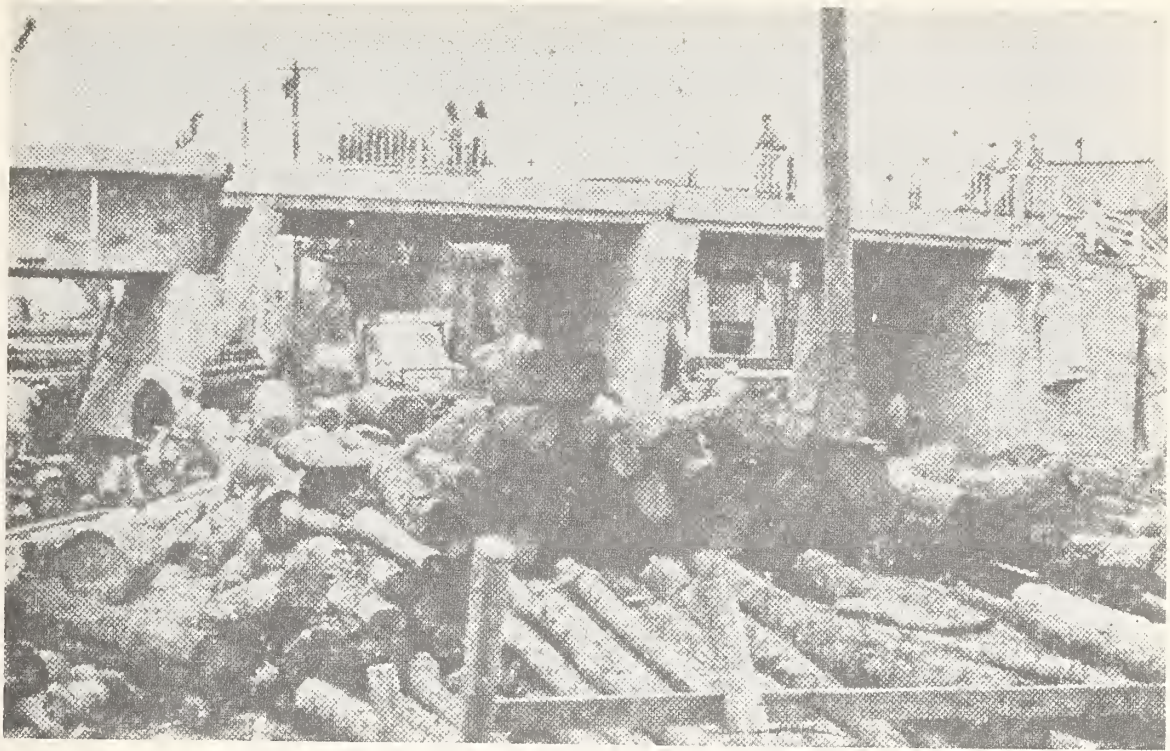
Photo. 2.48 Buckling feature of the pile shown in Photo 2.47.

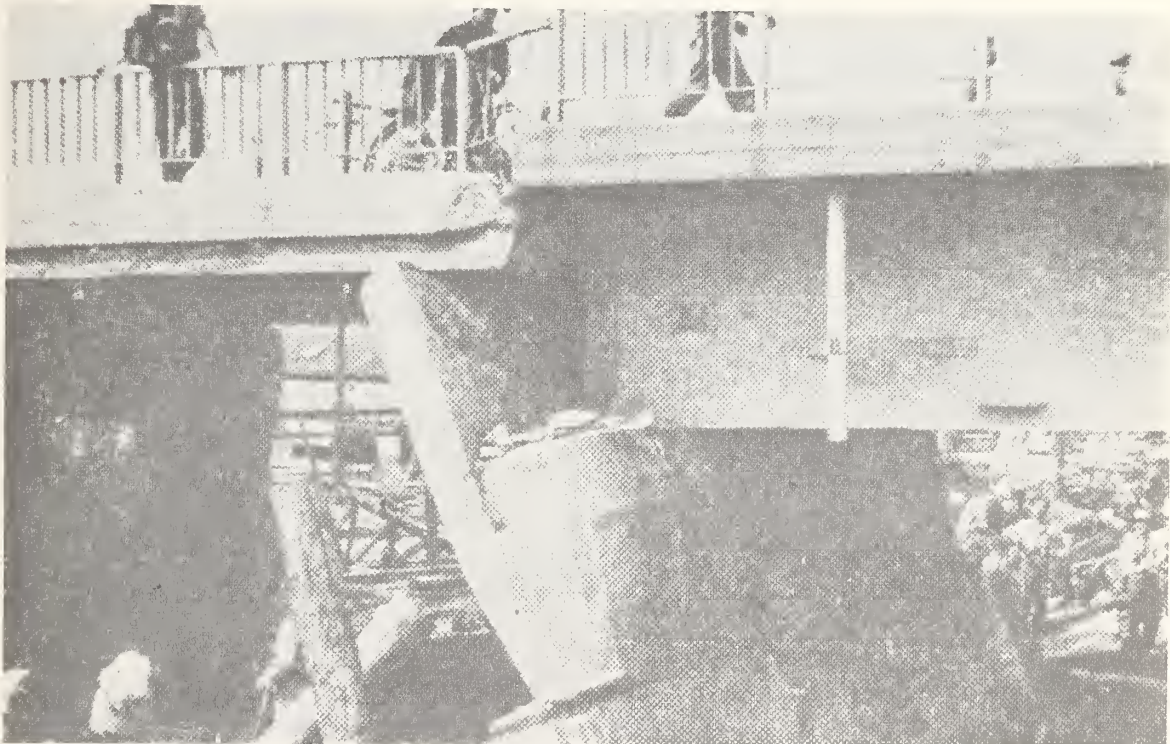
Photo. 2.49 Damage to the Yachi o bridge.
